08-24-BOD Agenda (November)

Nottawasaga Valley Conservation Authority

11.2.4. Staff Report No. 39-08-24-BOD from Dalia Al-Ali, Manager, Engineering Services regarding Review and Approval of Natural Hazard Infrastructure & Ice Management Plans

2024 DRAFT Watershed-based Resource Management Strategy

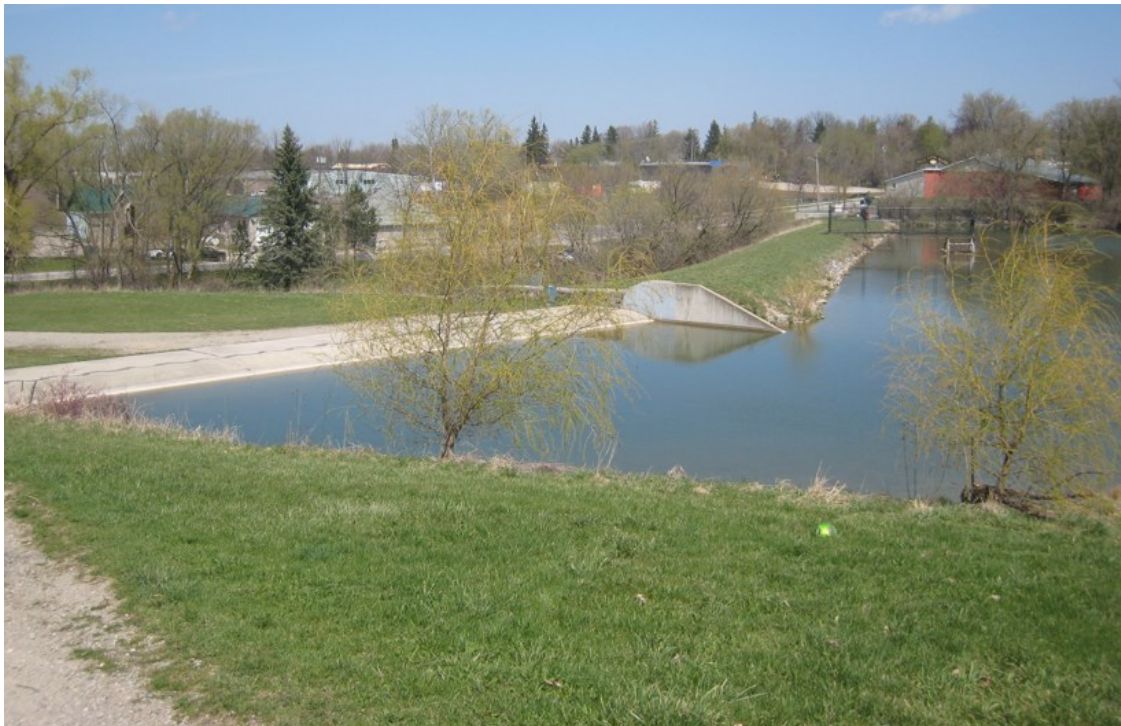
Figure 1. Tottenham Dam and reservoir.

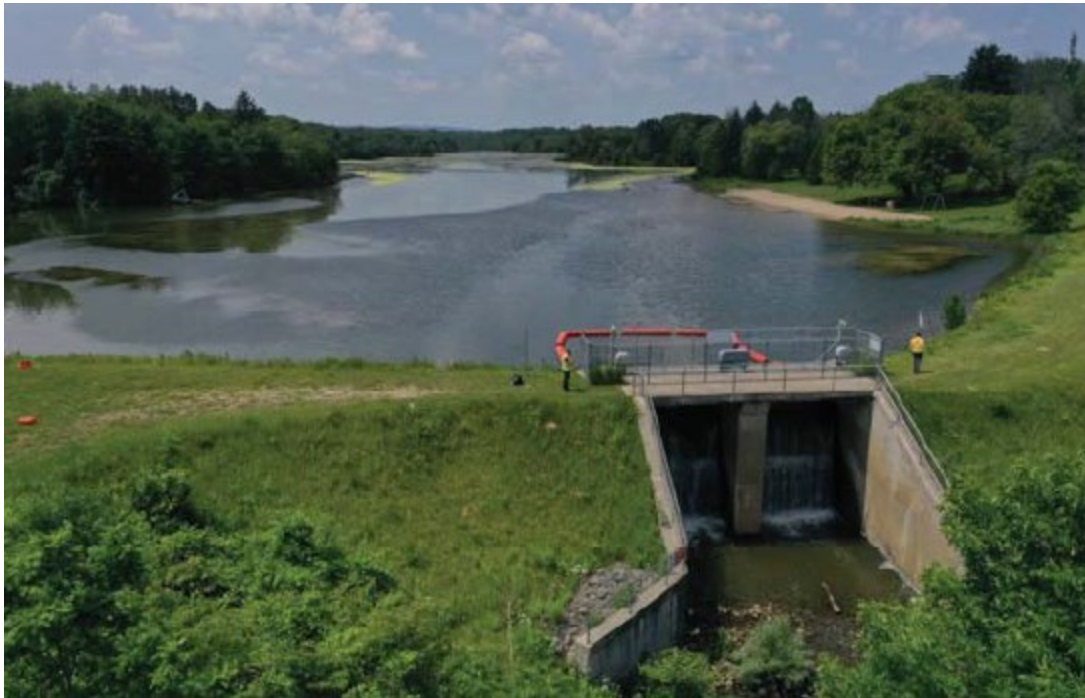
Figure 3. New Lowell Dam and reservoir during summer operations, with the public safety boom in place upstream of the concrete control structure (credit: D.M. Wills, July 5 2023).

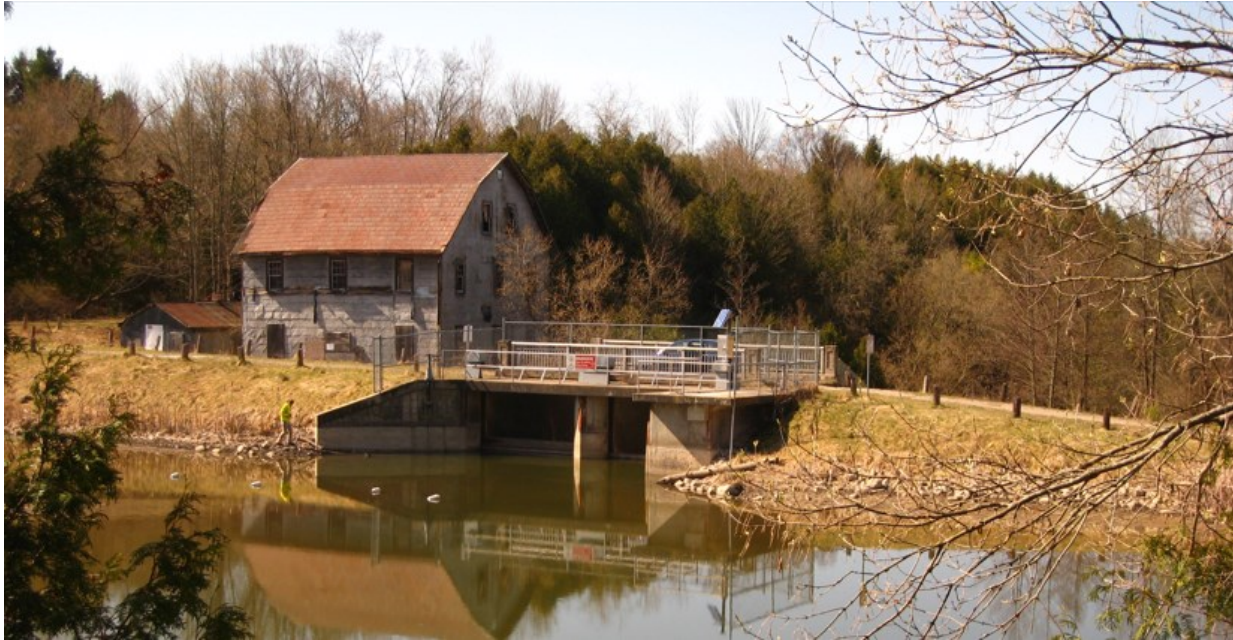
Figure 5. Utopia Dam and associated reservoir upstream of the dam.

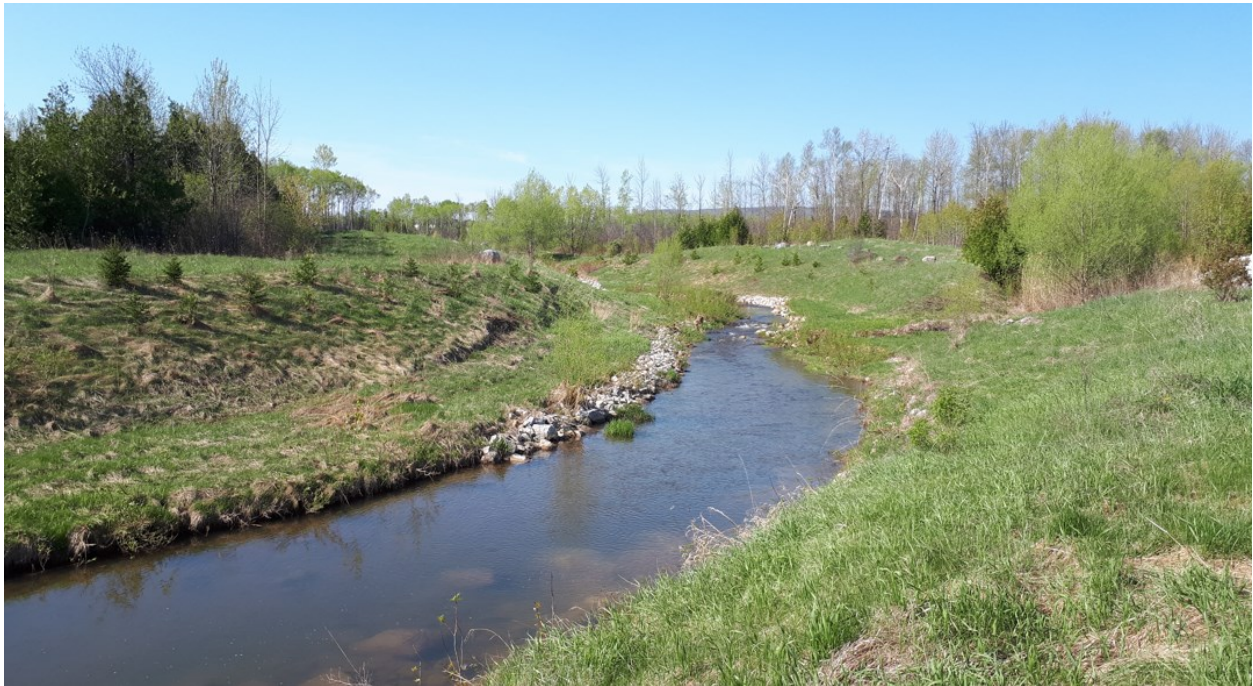
Figure 7. Black Ash Creek Floodway.

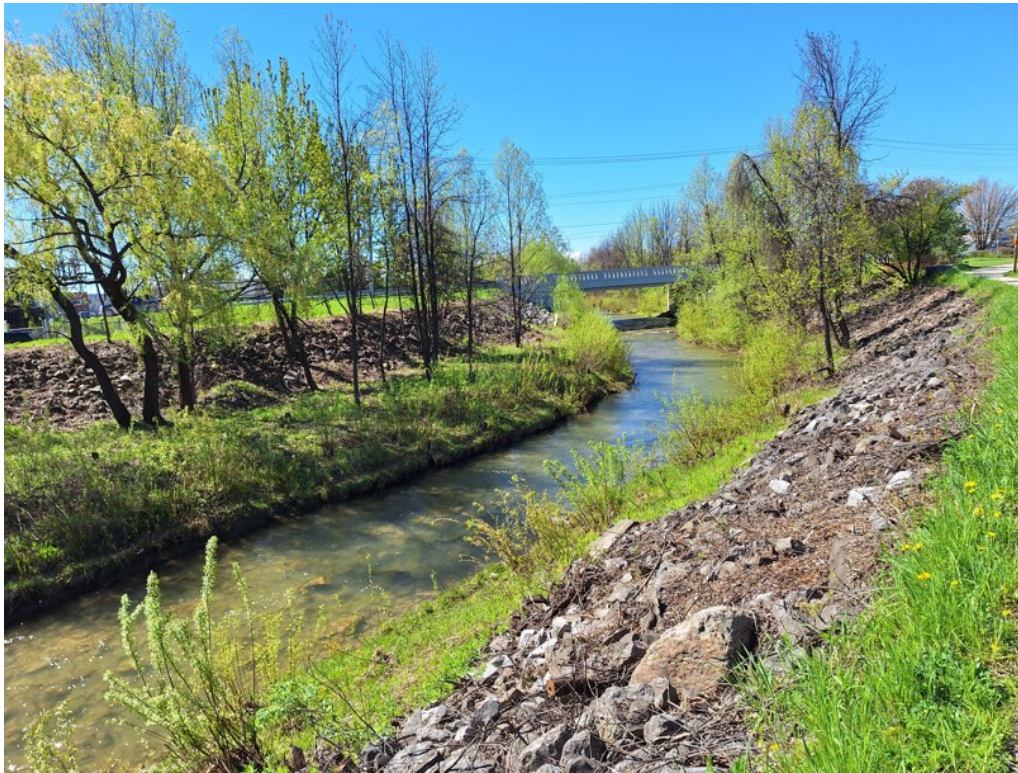
Figure 9. Pretty River Dike system lining the east and west banks of the Pretty River.

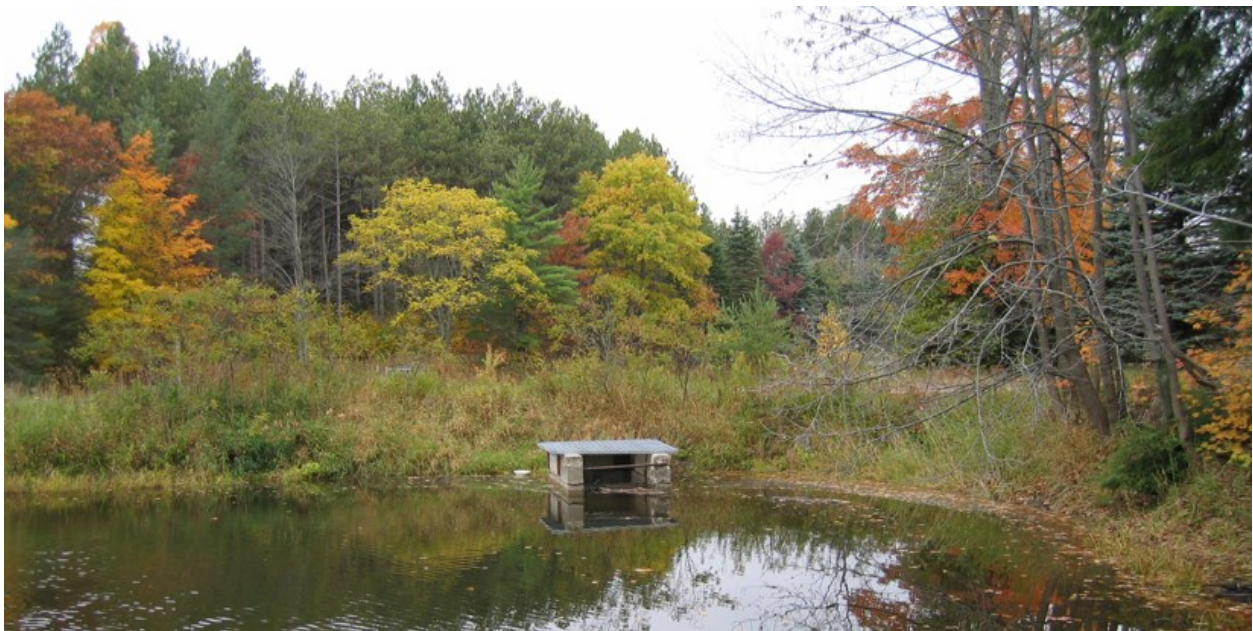
Figure 12. Poppa Bear Dam (a.k.a. Tiffin Pond Dam #2).
